Ground-truthing Survey Results

Figure 11. Orthomosaic image showing vegetation with damaged trees on limestone hills (A&B); damaged infrastructure and settlements (C) ; and uprooted palm trees (D) in Brgy. Caub, Del Carmen.

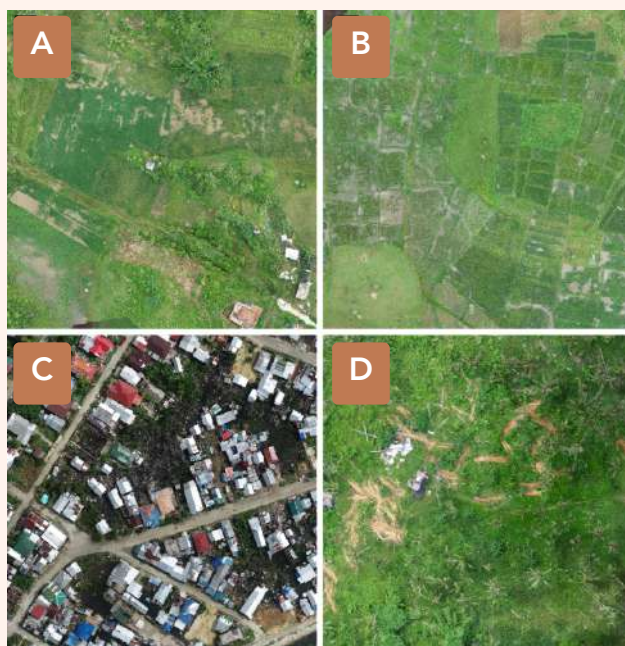
Figure 12. Orthomosaic image showing vegetation with damaged cropland (A & B); damaged infrastructure and settlements (C) ; and uprooted palm trees (D) in different barangay across the jurisdiction of Pilar.

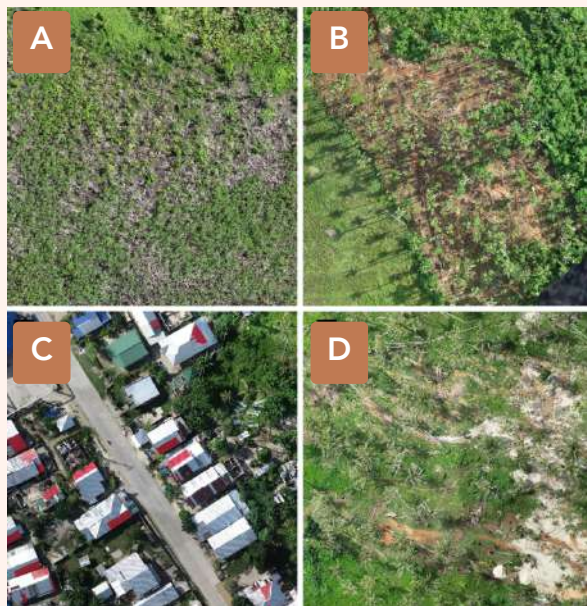
Figure 13. Orthomosaic image showing vegetation with damaged mangrove area (A); damaged infrastructure and settlements (C); and uprooted palm trees (B & D) in different barangay across the jurisdiction of Santa Monica.

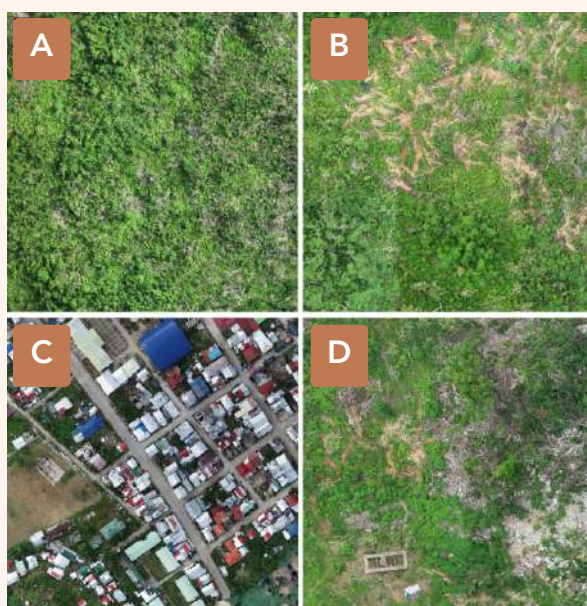
Figure 14. Orthomosaic image showing mixed vegetation (A); damaged infrastructure and settlements (C); and uprooted palm trees (B & D) in different barangay across the jurisdiction of Burgos.

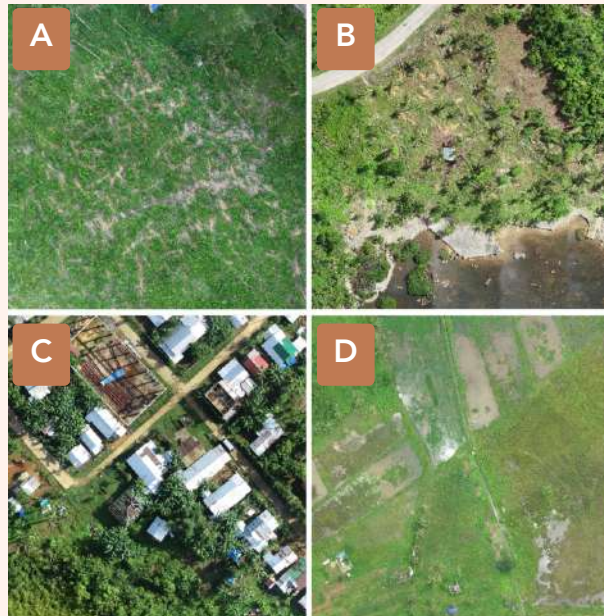
Figure 15. Orthomosaic image showing vegetation with uprooted palm trees (A & B); damaged infrastructure and settlements (C); and damaged cropland (D) in different barangay across the jurisdiction of San Isidro.

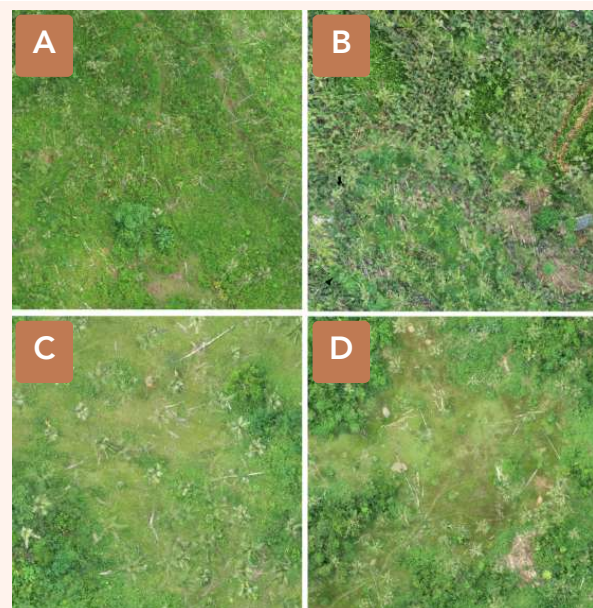
Figure 16. Orthomosaic image showing vegetation with damaged mixed vegetation and uprooted palm trees in different barangay across the jurisdiction of San Benito.

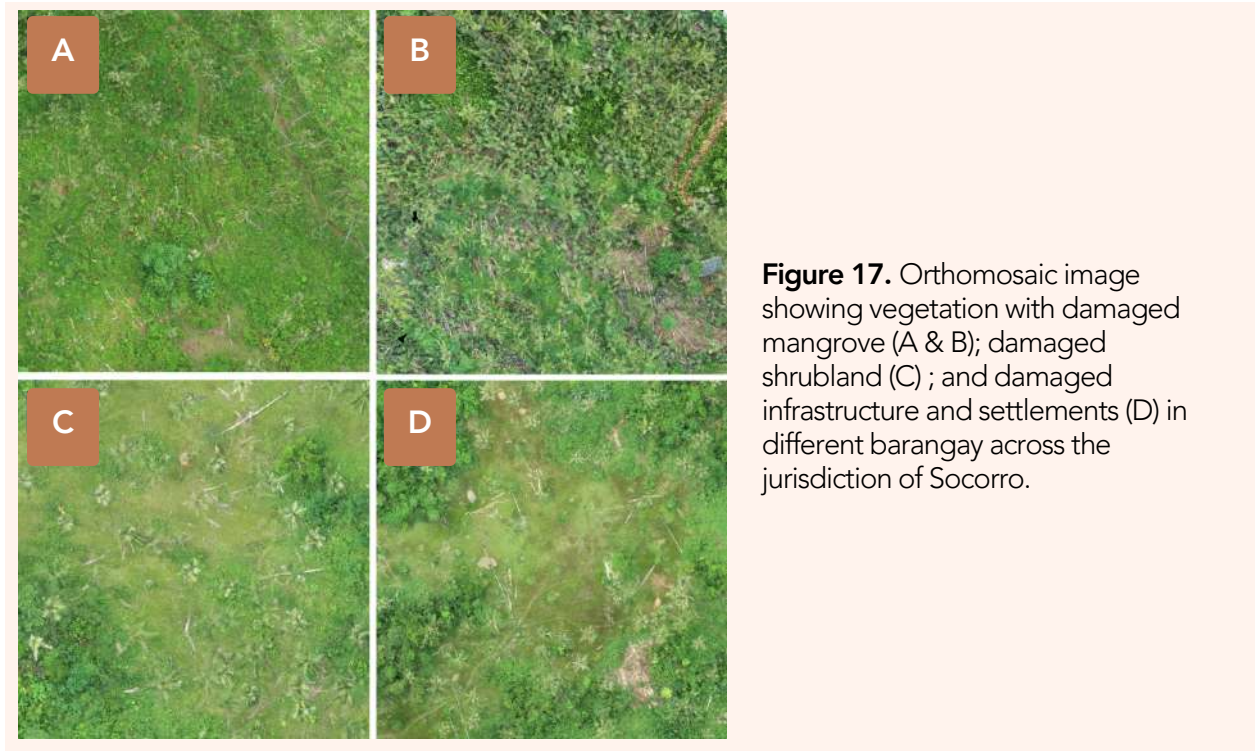
Figure 17. Orthomosaic image showing vegetation with damaged mangrove (A & B); damaged shrubland (C) ; and damaged infrastructure and settlements (D) in different barangay across the jurisdiction of Socorro.

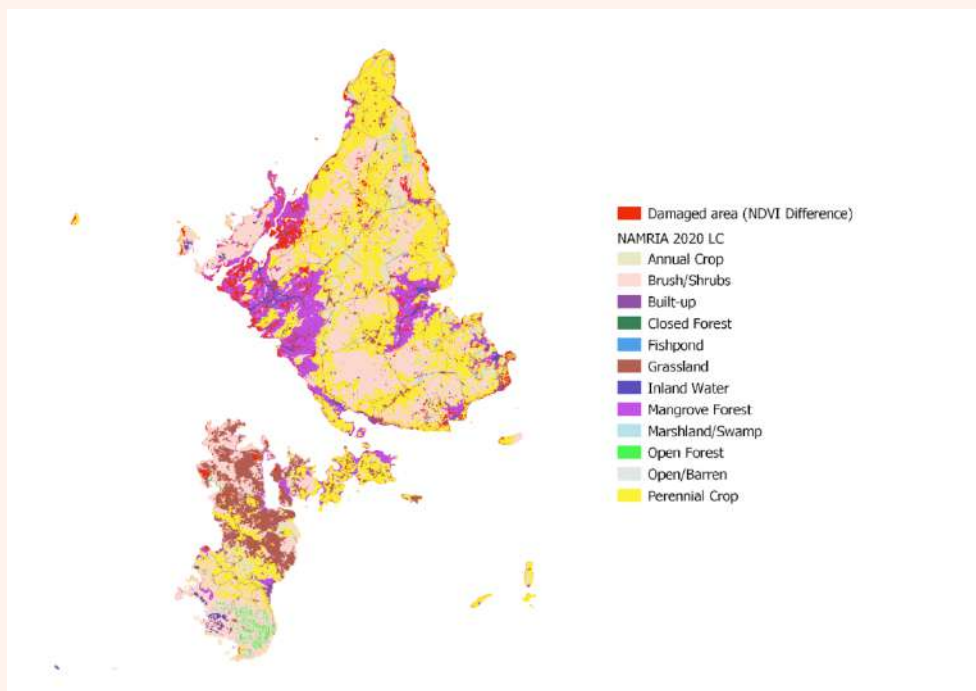
Figure 18. Overlay of the NDVI difference map from Stage 1 with the 2020 NAMRIA land cover map. Red pixels indicate areas where probable vegetation damages occurred.

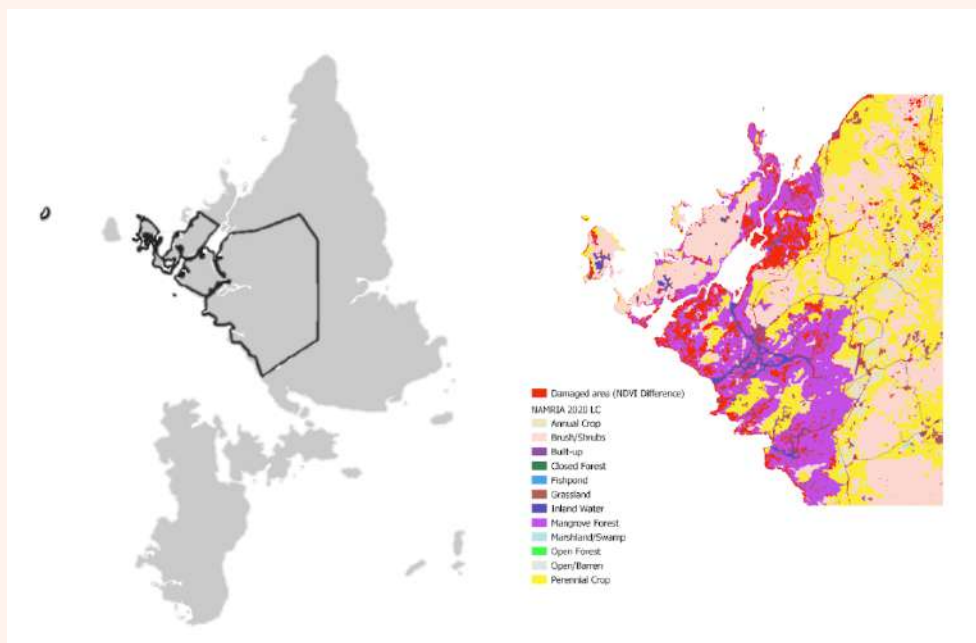
Figure 19. A closer look of the Municipality of Del Carmen showing an overlay of the NDVI map from Stage 1 with the 2020 NAMRIA land cover map. Red pixels indicate areas where probable vegetation damages occurred.

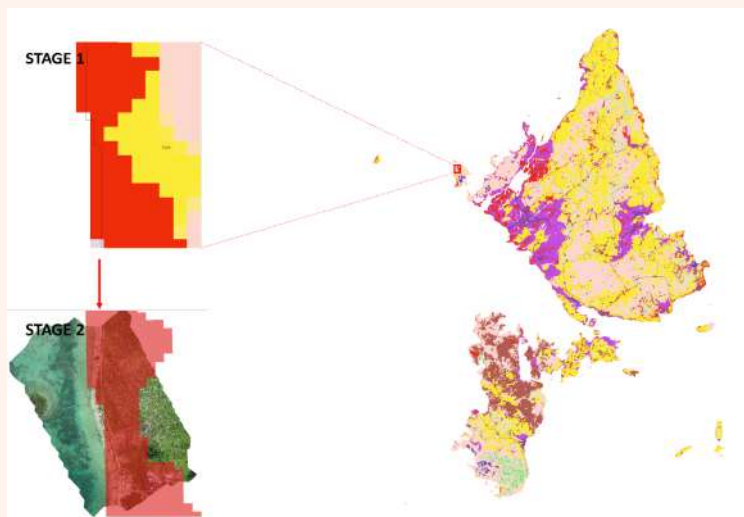
Figure 20. Sample output of the RPA survey collected in Brgy. Caub, Del Carmen; superimposed with the results of the NDVI difference map from Stage 1. Red pixels indicate areas where probable vegetation damages occurred.

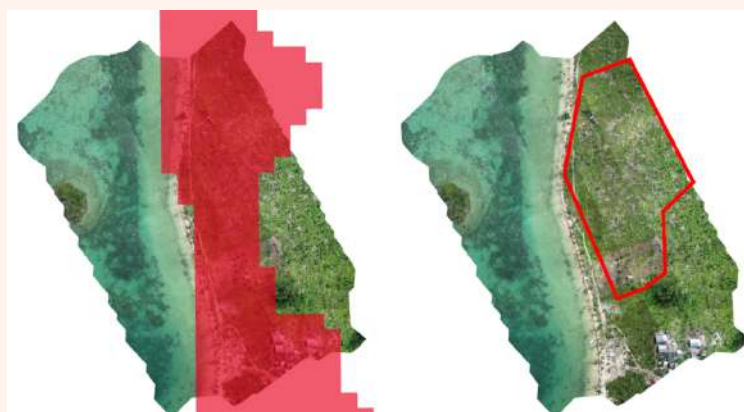
Figure 21. SOrthomosaic image captured in Brgy. Caub, Del Carmen showing uprooted and defoliated palm trees. Red polygon on the right image shows uprooted palm trees.

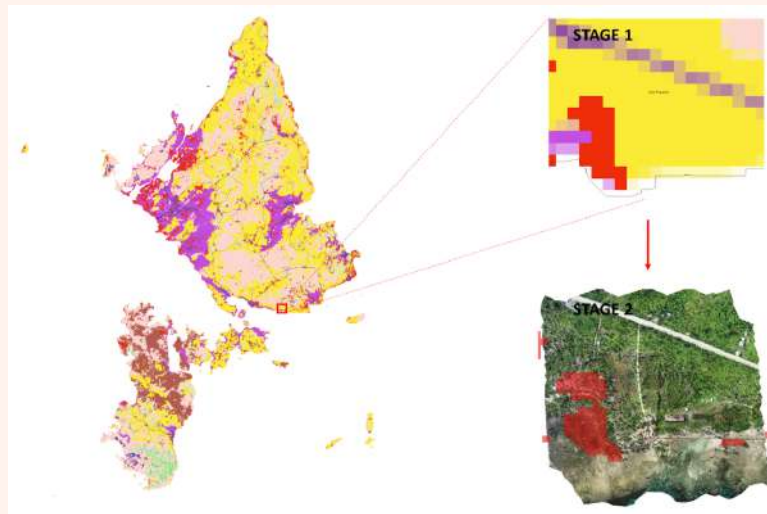
Figure 22. Sample output of the RPA survey in Brgy. Don Paulino, Dapa; superimposed with the results of the NDVI difference map from Stage 1. Red pixels indicate areas where probable vegetation damages occurred.

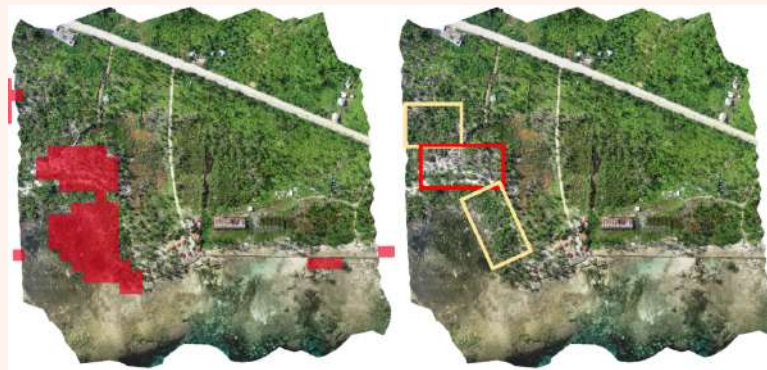
Figure 23. Orthomosaic image captured in Brgy. Don Paulino. Yellow box shows damage in mangrove areas, while the red box shows uprooted palm trees.
